# Late Migration of Threaded Wire (Schanz Screw) from Right Distal Clavicle to the Cervical Spine

We report a 49-year-old man who had undergone osteosynthesis to treat right distal clavicular fracture with a threaded wire (Schanz screw). The wire could not be removed due to its firm fixation within the bone. Eight years later, migration of the broken wire to the right 7<sup>th</sup> cervical vertebra punctured the lamina, with no spinal cord injury noted. The threaded wire was extracted from the C7 lamina emergently. No complication occurred after pin removal or during the 1-year post-operative follow-up. [*J Chin Med Assoc* 2009;72(1):48–51]

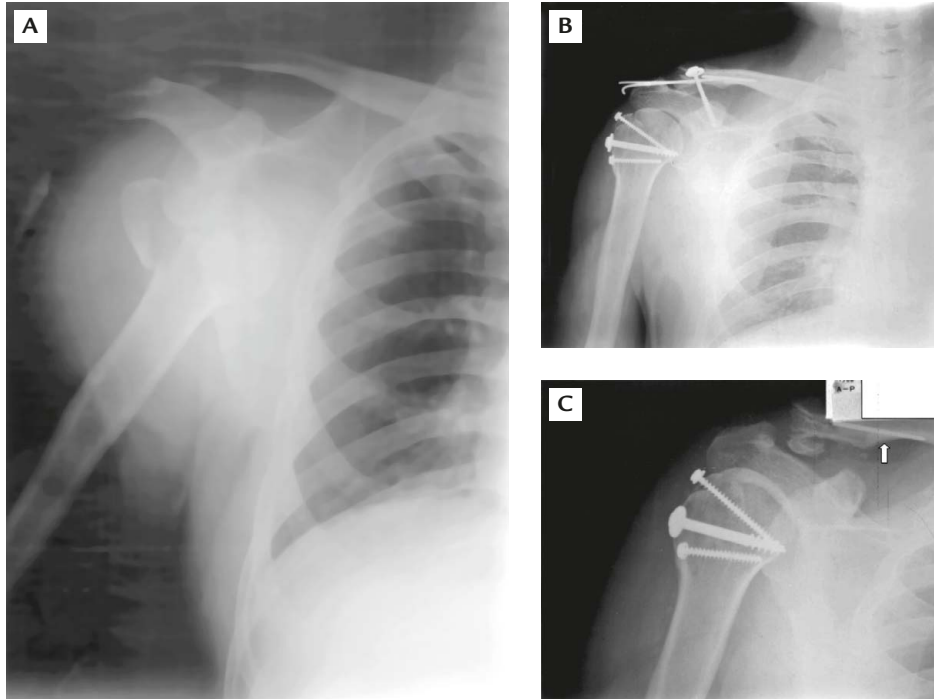
**Figure 1.** (A) Preoperative radiograph of the right shoulder shows displaced right distal clavicular fracture with fracture–dislocation of the right shoulder. (B) X-ray obtained 3 months after osteosynthesis reveals a broken wire at the distal clavicle area. (C) The internal fixators were removed except for the broken wire.

fixation with 2 threaded wires for his clavicle fracture at a local clinic. Three months after the operation, a broken wire was noted (Figure 1). The implants were removed at the local clinic 4 months after the 1<sup>st</sup> operation. The broken wire could not be removed as the threaded wire had firmly fixed to the clavicle. Despite this, the patient did not complain of any discomfort and no further imaging of the involved region was performed.

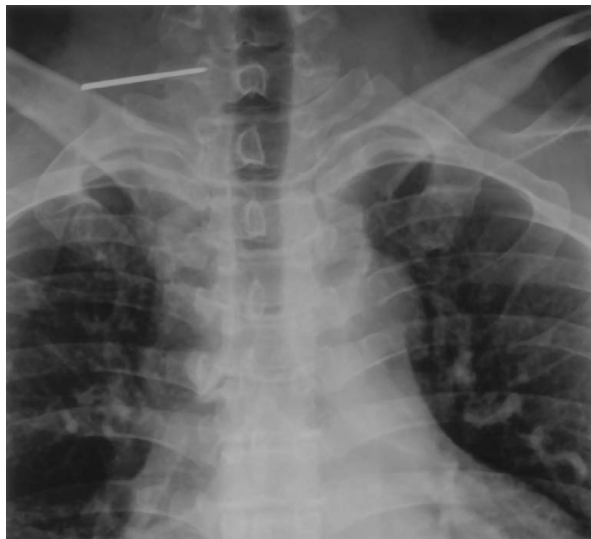
**Figure 2.** Chest X-ray shows the migrated wire at the C7 vertebra.

On physical examination, tenderness over the right upper area of the chest region was evident, which was exacerbated during deep inspiration. No weakness or paresthesia of any limbs was noted. Posteroanterior chest radiography showed that 1 wire fragment had migrated to the right C7 vertebra (Figure 2). Computed tomography of the cervical spine demonstrated a wire fragment about 39 mm in length penetrating the lamina of the right C7 without entering the spinal canal (Figure 3).

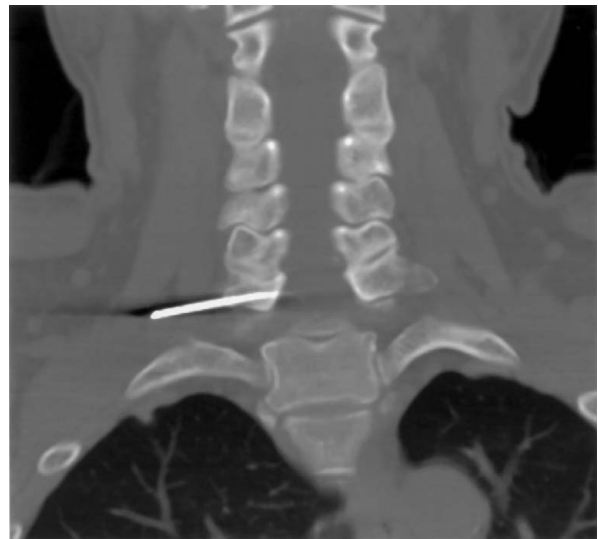
**Figure 3.** Computed tomography of the cervical spine shows that the wire has penetrated the right vertebral body without entering the epidural space.

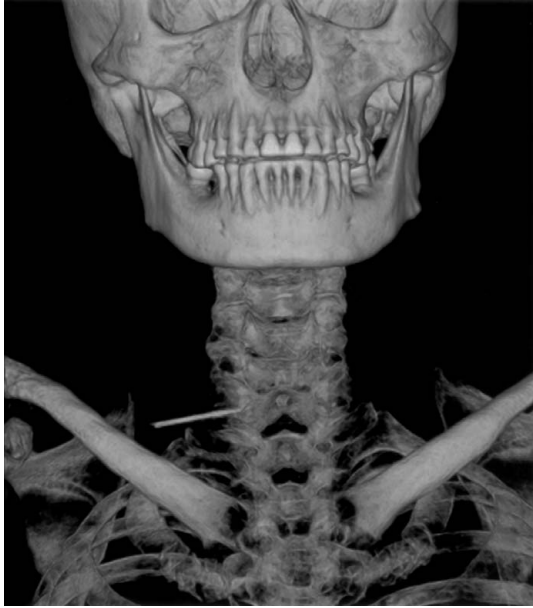
**Figure 4.** Three-dimensional reconstructed computed tomography scans of the cervical spine show the migrated wire over the right side of C7.

Three-dimensional reconstruction of computed tomography images was performed to more accurately assess the position of the wire in the C7 vertebra (Figure 4). Open surgical removal of the wire was performed in an emergency operation. The extracted broken Schanz screw is shown in Figure 5. At the 1-year postoperative follow-up examination, the patient had no symptoms in the right clavicle region or right upper limbs.

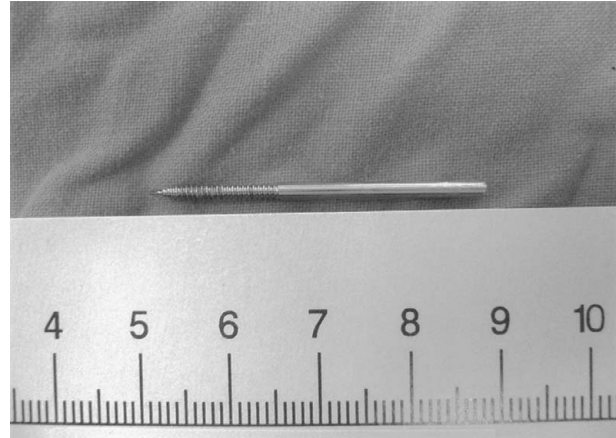
**Figure 5.** The migrated wire was removed. It was threaded and about 39 mm in length.
